Facility: Thomas Hayward Agriculture & Nutrition

Subject: Area in front of the facility (on the south side of the property) looking west with the Harcros facility in the background.

RCRA 6/27/1995

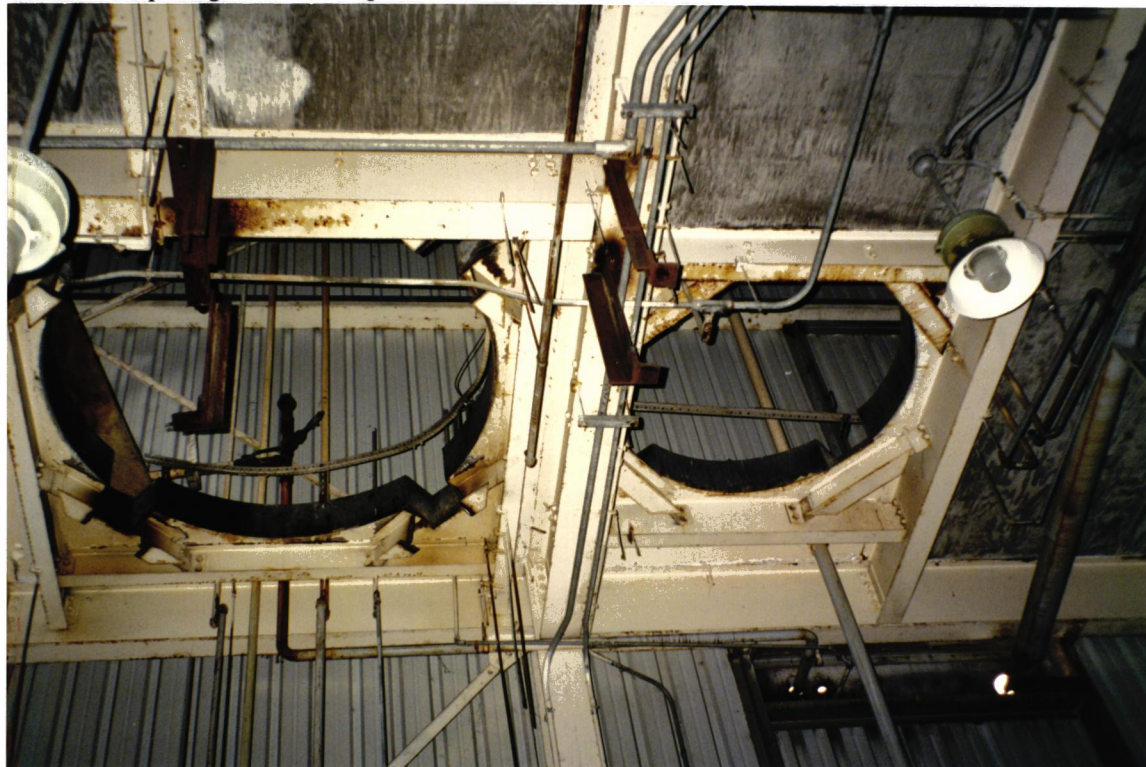
28

Subject: View of two additional, smaller openings in ceiling that formerly housed tanks (1st floor).

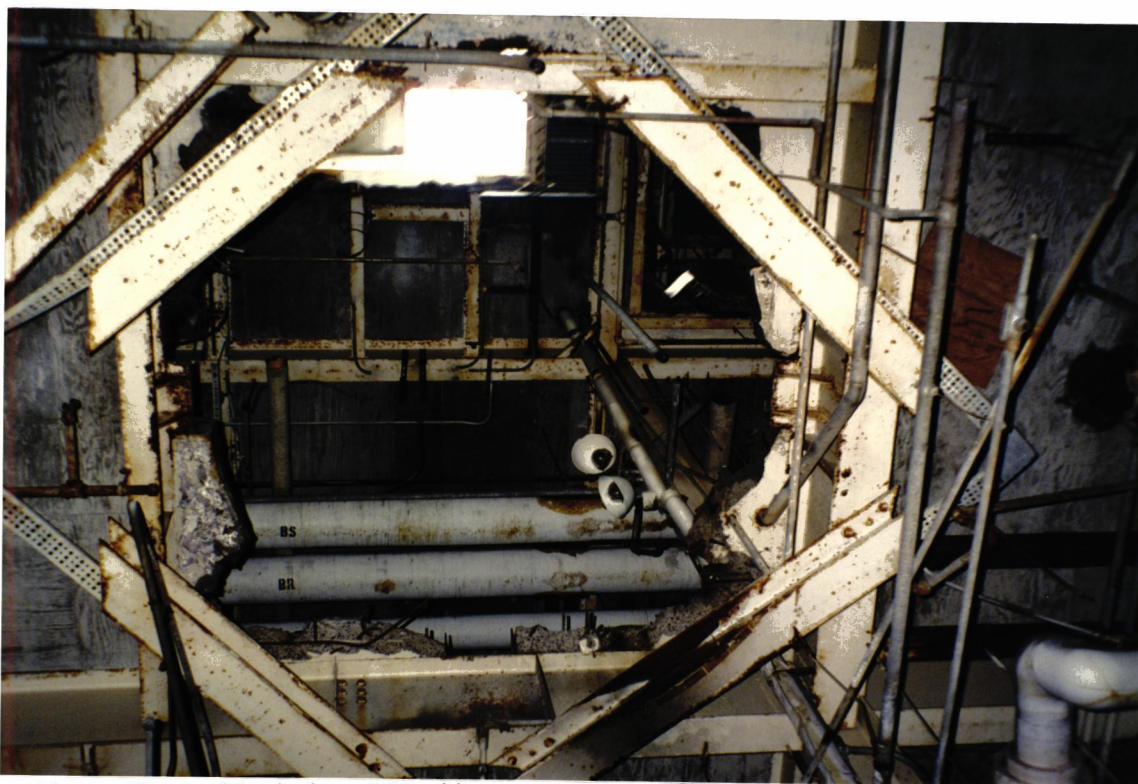
Facility: Thomas Hayward Agriculture & Nutrition
Location: Kansas City, KS **Photographer:** Jeffery Robichaud **Witness:** James Aycock **Date:** 6/27/95
Direction: N/A **Camera Type:** Fuji 35mm **Film Type:** 200 ASA **Time:** 0931
Subject: View of a large opening in ceiling that formerly housed tanks.

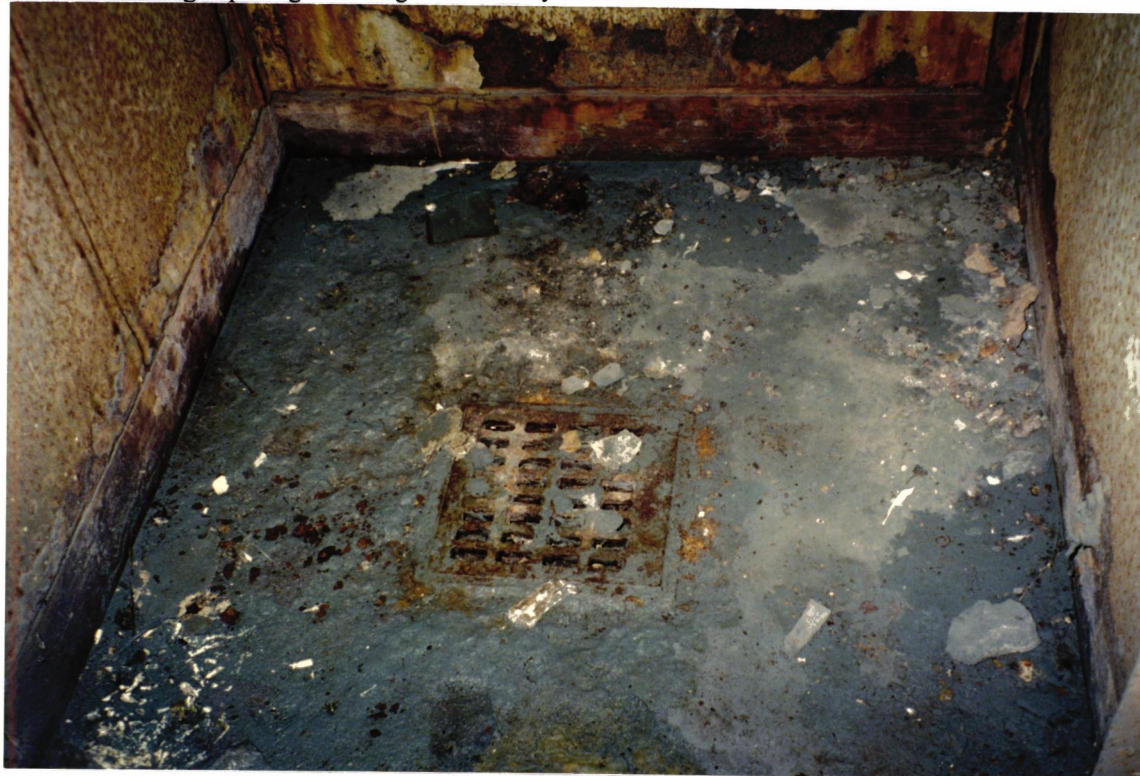
30

Facility: Thomas Hayward Agriculture & Nutrition
Location: Kansas City, KS **Photographer:** Jeffery Robichaud **Witness:** James Aycock **Date:** 6/27/95
Direction: N/A **Camera Type:** Fuji 35mm **Film Type:** 200 ASA **Time:** 0932
Subject: Photo of the floor drain in what was described as the former welding booth located in the southeast corner of the first floor of the former DAITOM plant.

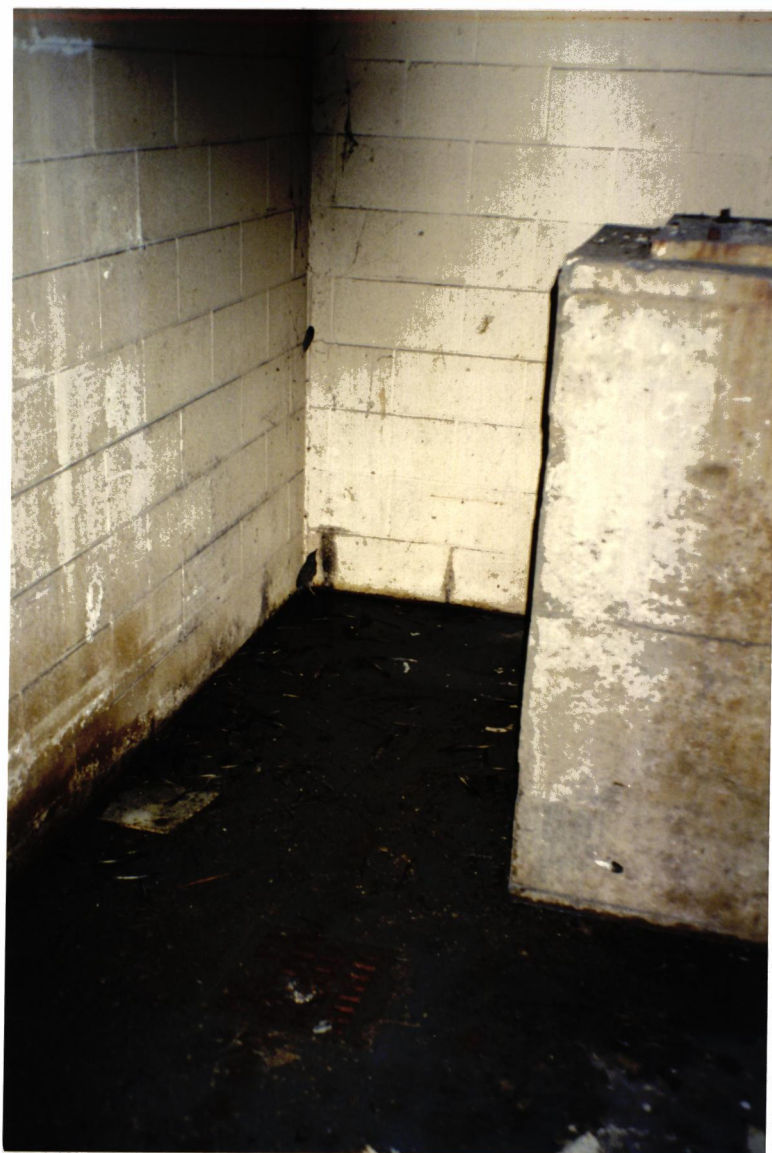
ROLL 1 PHOTO 31

Subject: View of the drain in the northwest corner of the northeastern section of the first floor of the DAITOM plant.

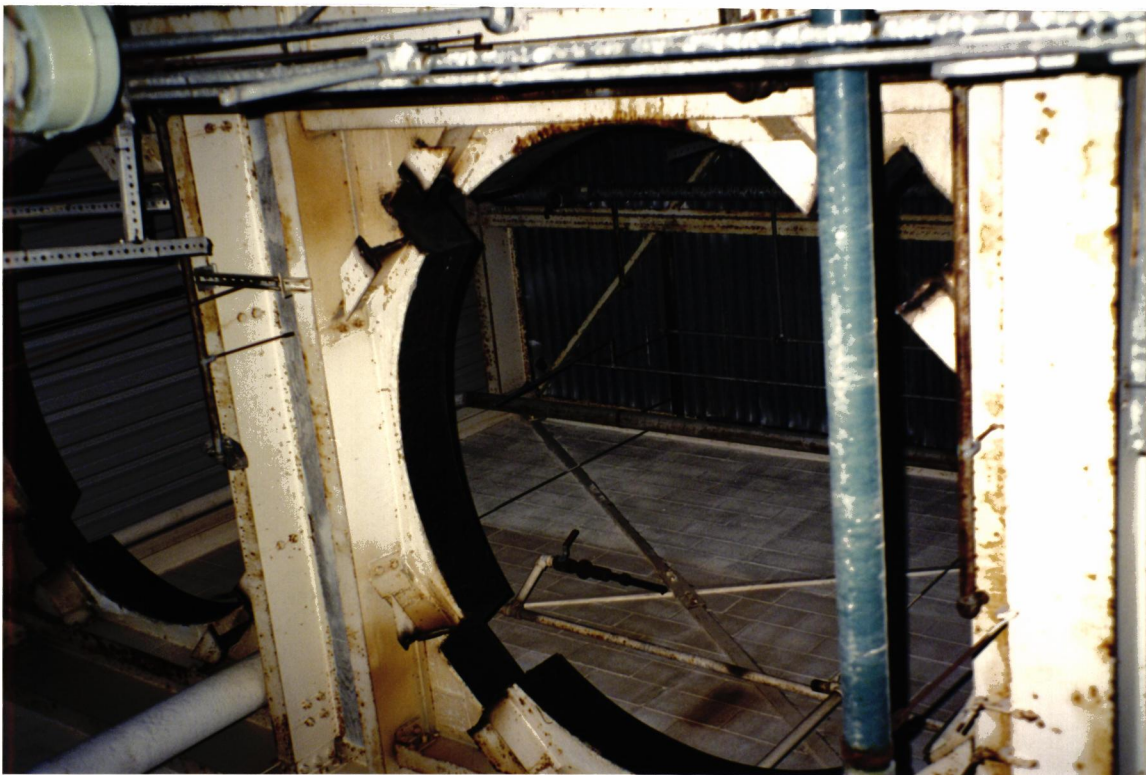
Facility: Thomas Hayward Agriculture & Nutrition
Location: Kansas City, KS **Photographer:** Jeffery Robichaud **Witness:** James Aycock **Date:** 6/27/95
Direction: N/A **Camera Type:** Fuji 35mm **Film Type:** 200 ASA **Time:** 0943
Subject: View of openings in the ceiling of the second floor which formerly housed tanks.

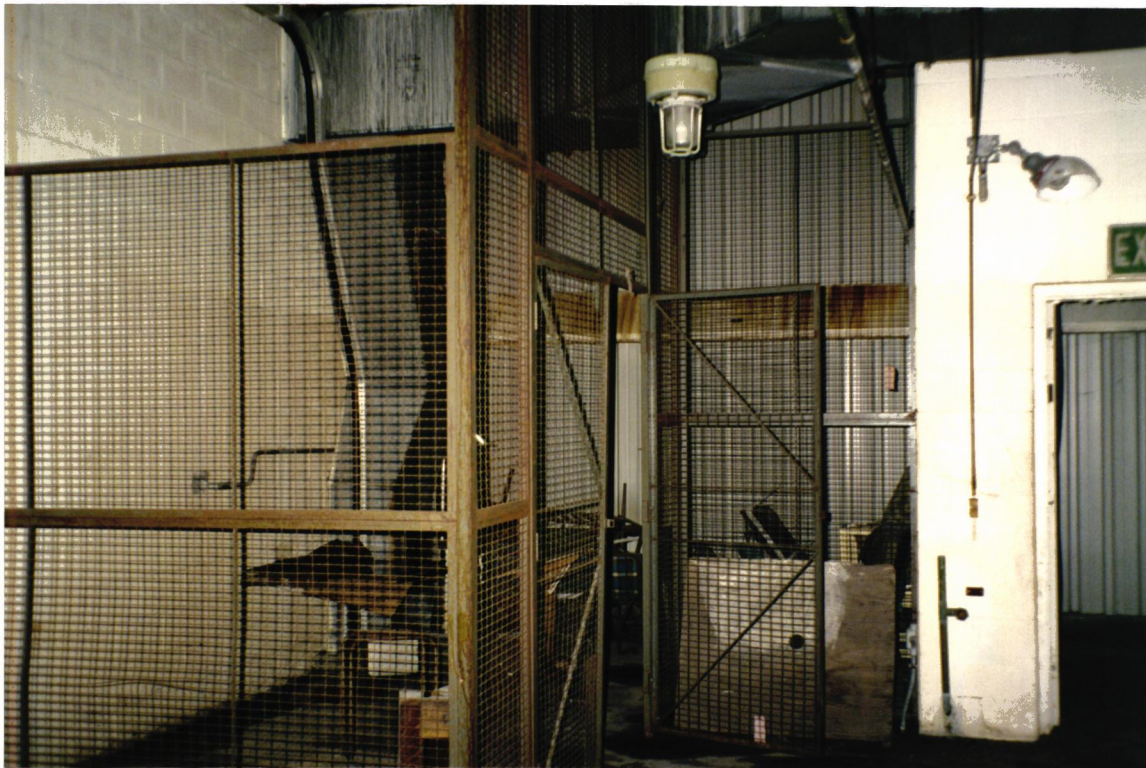
33

Facility: Thomas Hayward Agriculture & Nutrition
Location: Kansas City, KS **Photographer:** Jeffery Robichaud **Witness:** James Aycock **Date:** 6/27/95
Direction: North **Camera Type:** Fuji 35mm **Film Type:** 200 ASA **Time:** 0945
Subject: View of the former cyanide storage area located inside the cage.

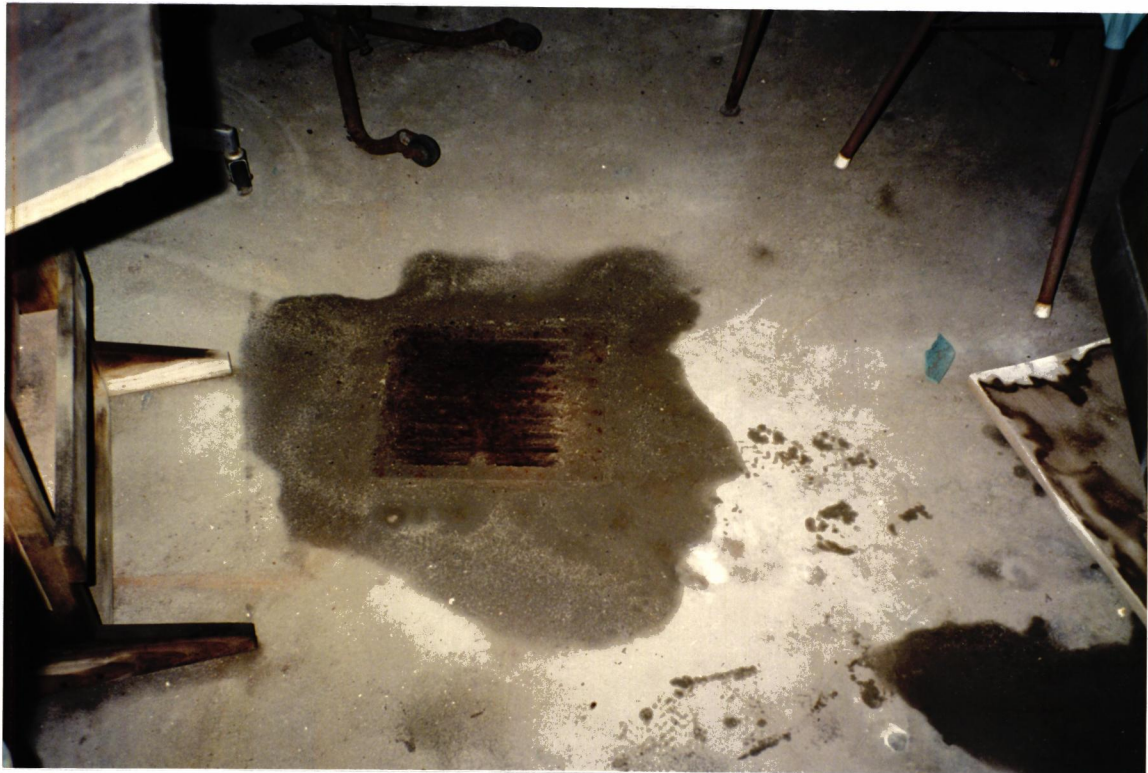
Subject: View of the drain inside the former cyanide storage area.

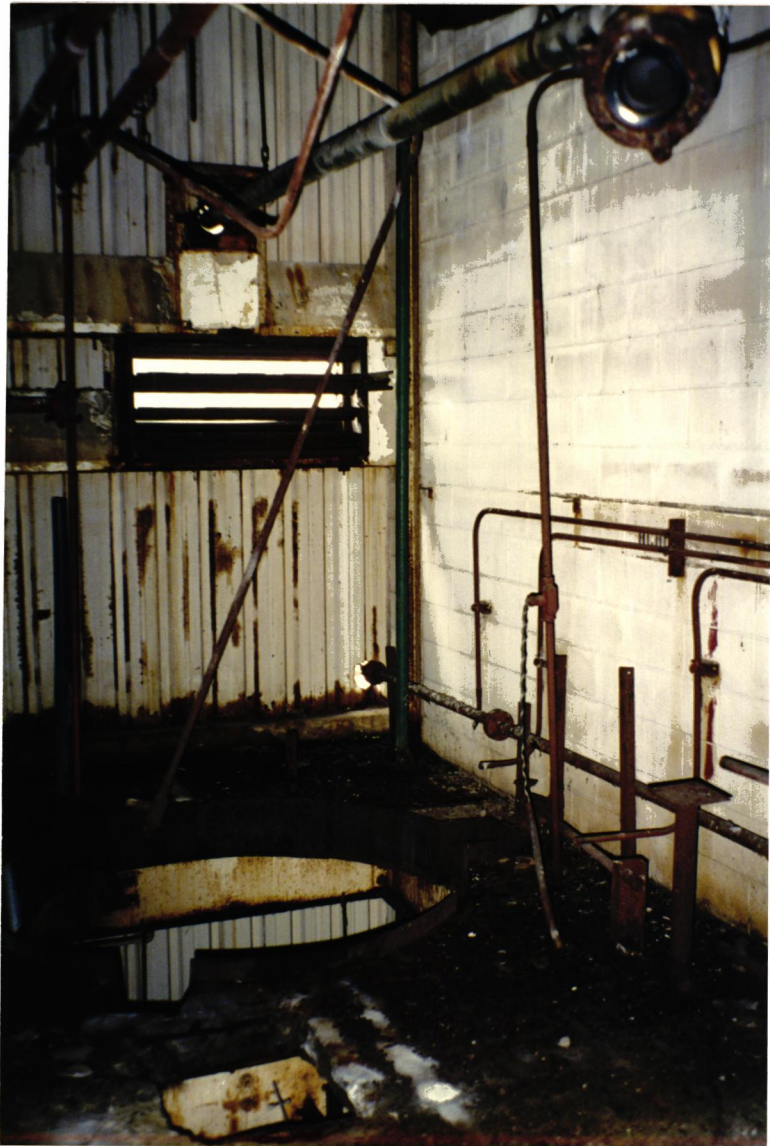
ROLL 1 PHOTO 35

Subject: View of opening in floor where a cyanide reactor was formerly housed. Note the white build-up on the floor and the pipes.

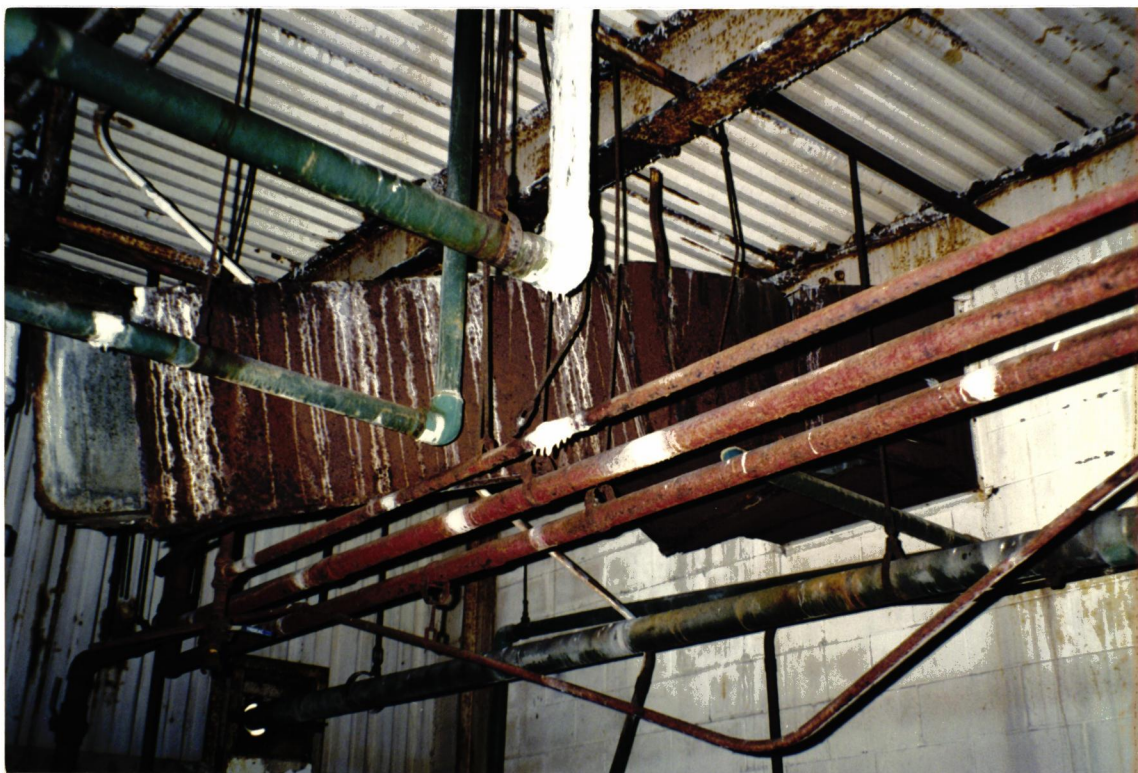
37

Facility: Thomas Hayward Agriculture & Nutrition
Location: Kansas City, KS **Photographer:** Jeffery Robichaud **Witness:** James Aycock **Date:** 6/27/95
Direction: N/A **Camera Type:** Fuji 35mm **Film Type:** 200 ASA **Time:** 0948
Subject: View of the piping in the former sodium cyanide room. Note the white build-up on the I-beams and piping.

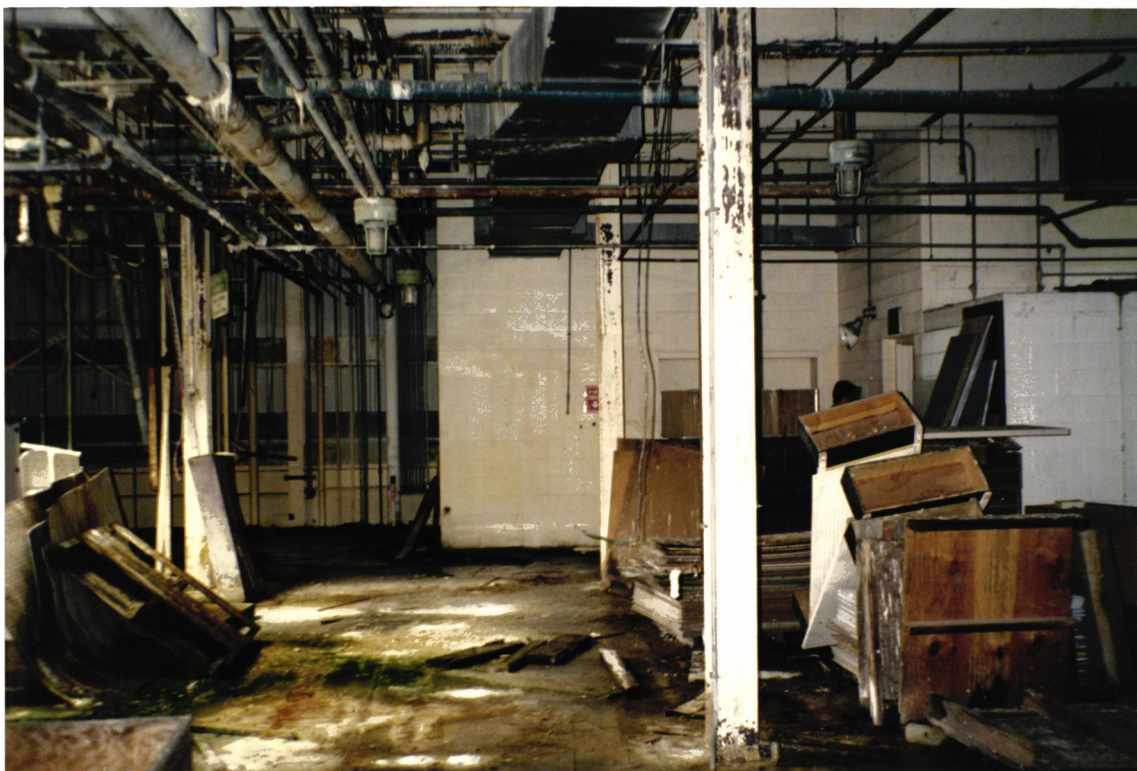
1

Facility: Thomas Hayward Agriculture & Nutrition
Location: Kansas City, KS **Photographer:** Jeffery Robichaud **Witness:** James Aycock **Date:** 6/27/95
Direction: West **Camera Type:** Fuji 35mm **Film Type:** 200 ASA **Time:** 0950
Subject: View of the third floor looking west. Note white build-up on pipes.

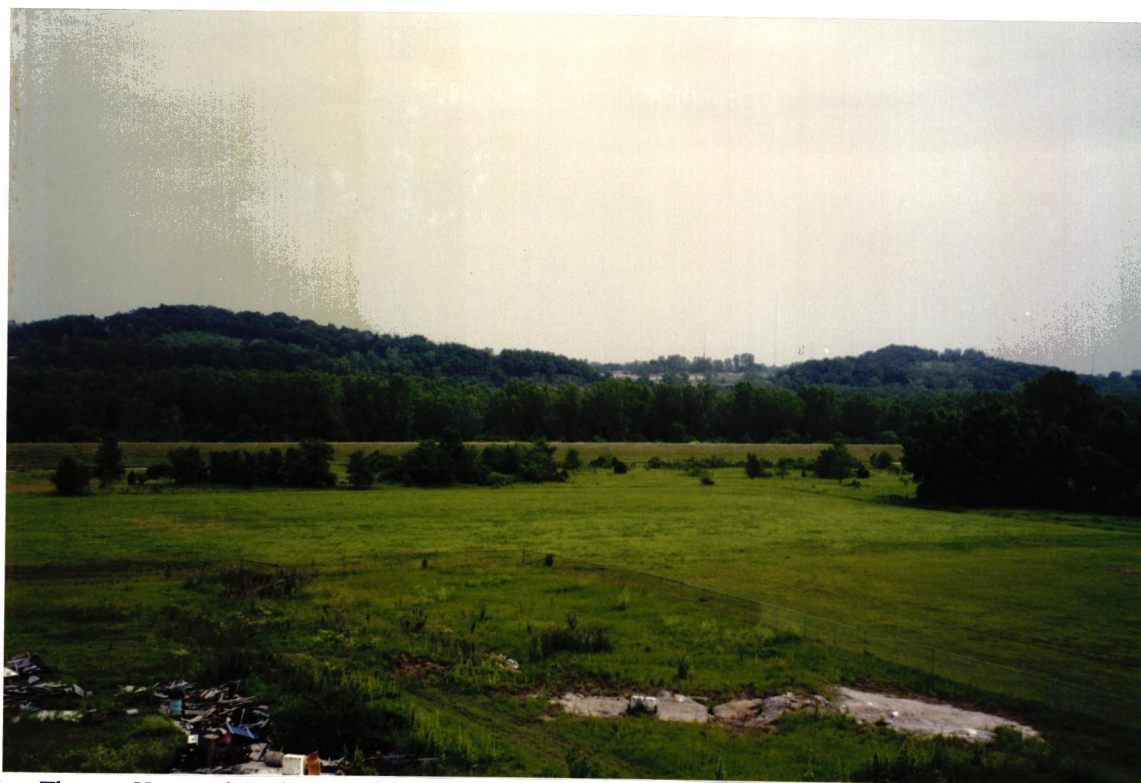
Subject: View of the former surface impoundment from the roof looking northeast.

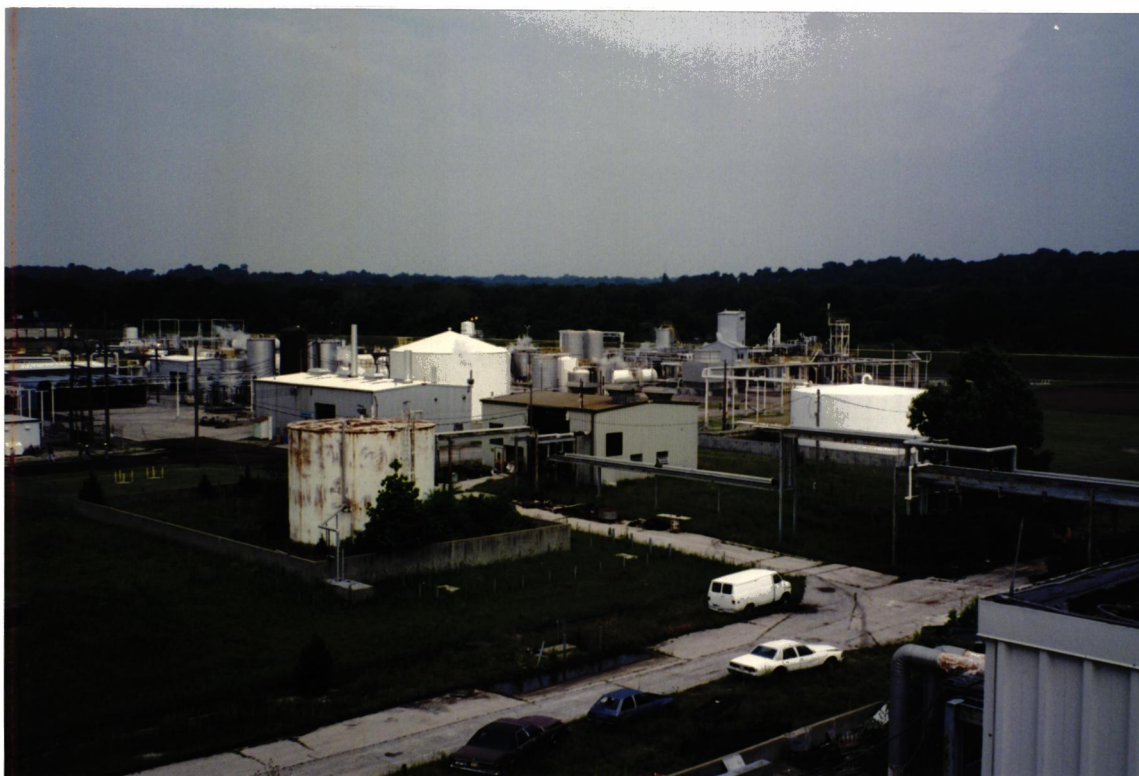
7

Facility: Thomas Hayward Agriculture & Nutrition
Location: Kansas City, KS **Photographer:** Jeffery Robichaud **Witness:** None **Date:** 6/27/95
Direction: Northwest **Camera Type:** Fuji 35mm **Film Type:** 200 ASA **Time:** 1005
Subject: View of the #5 diesel fuel tank and former boiler building in the center of the photo, Harcros facility in the background.

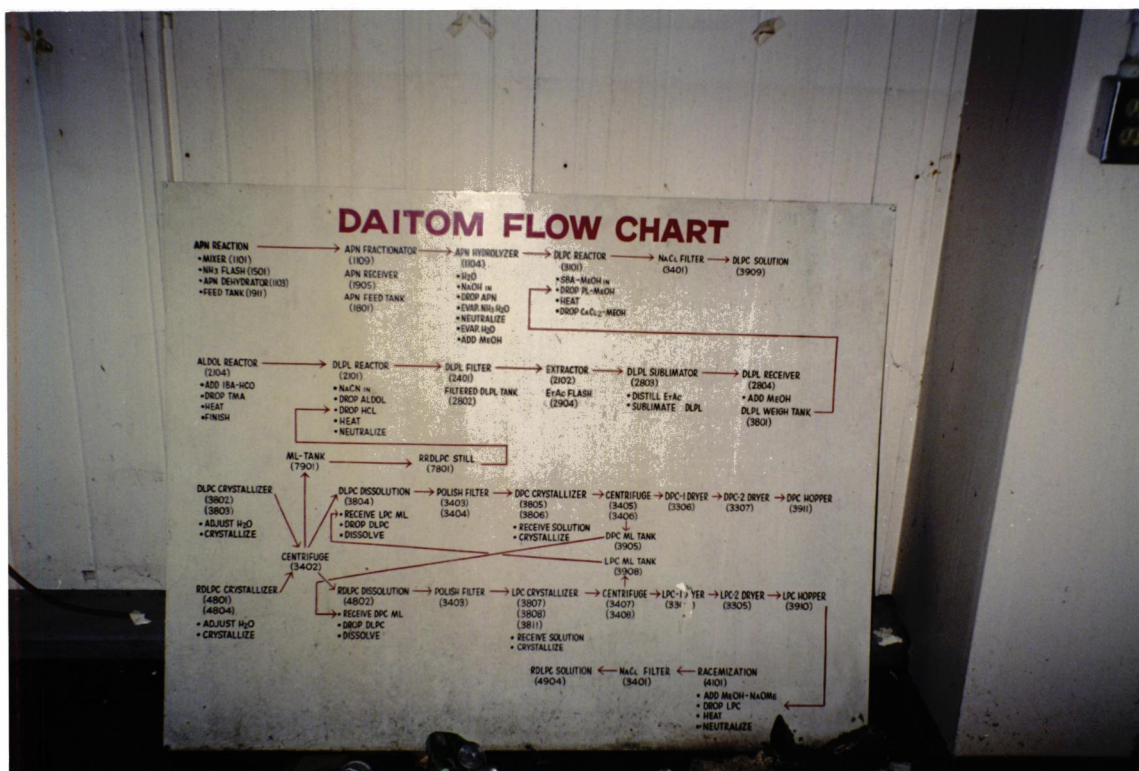
8

Facility: Thomas Hayward Agriculture & Nutrition
Location: Kansas City, KS **Photographer:** Jeffery Robichaud **Witness:** James Aycock **Date:** 6/27/95
Direction: N/A **Camera Type:** Fuji 35mm **Film Type:** 200 ASA **Time:** 1015
Subject: DAITOM Flow Chart found in plant manager's office

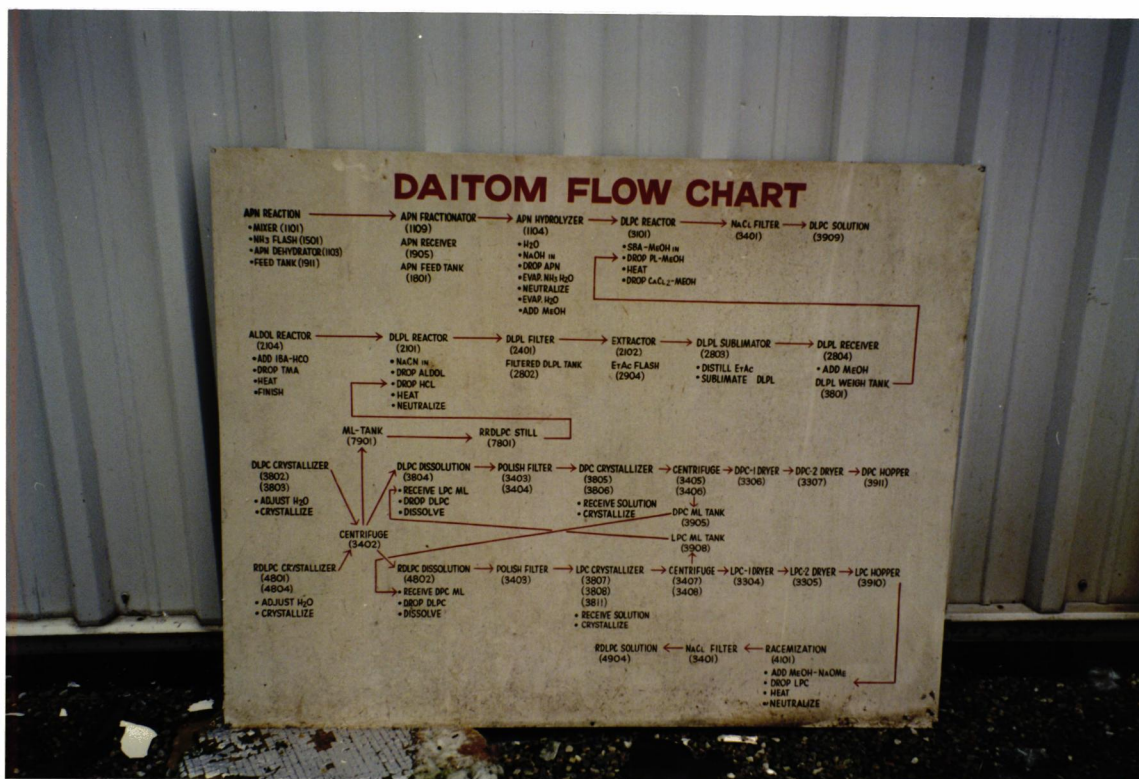
9

Facility: Thomas Hayward Agriculture & Nutrition
Location: Kansas City, KS Photographer: Jeffery Robichaud Witness: James Aycock Date: 6/27/95
Direction: N/A Camera Type: Fuji 35mm Film Type: 200 ASA Time: 1017
Subject: DAITOM flow chart

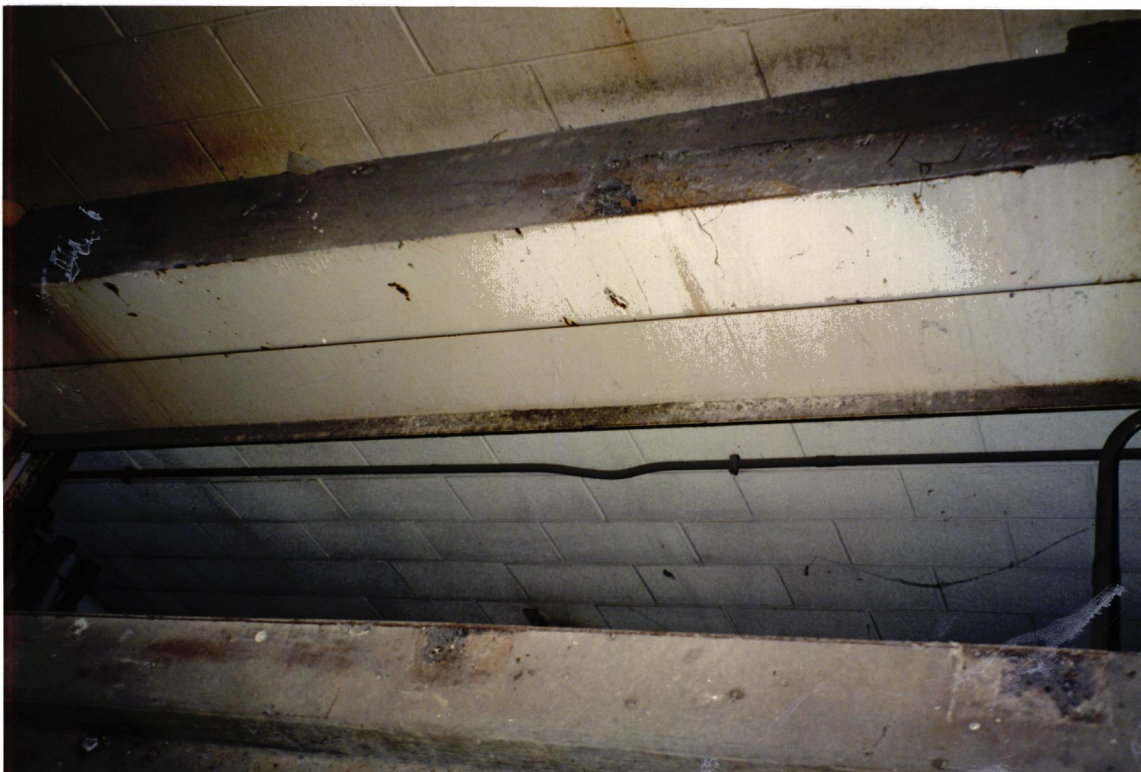
R
O
L
L
2
P
H
O
T
O
11

Facility: Thomas Hayward Agriculture & Nutrition
Location: Kansas City, KS **Photographer:** Jeffery Robichaud **Witness:** James Aycock **Date:** 6/27/95
Direction: N/A **Camera Type:** Fuji 35mm **Film Type:** 200 ASA **Time:** 1025
Subject: View of an opening in the second floor that formerly held an unknown process tank.

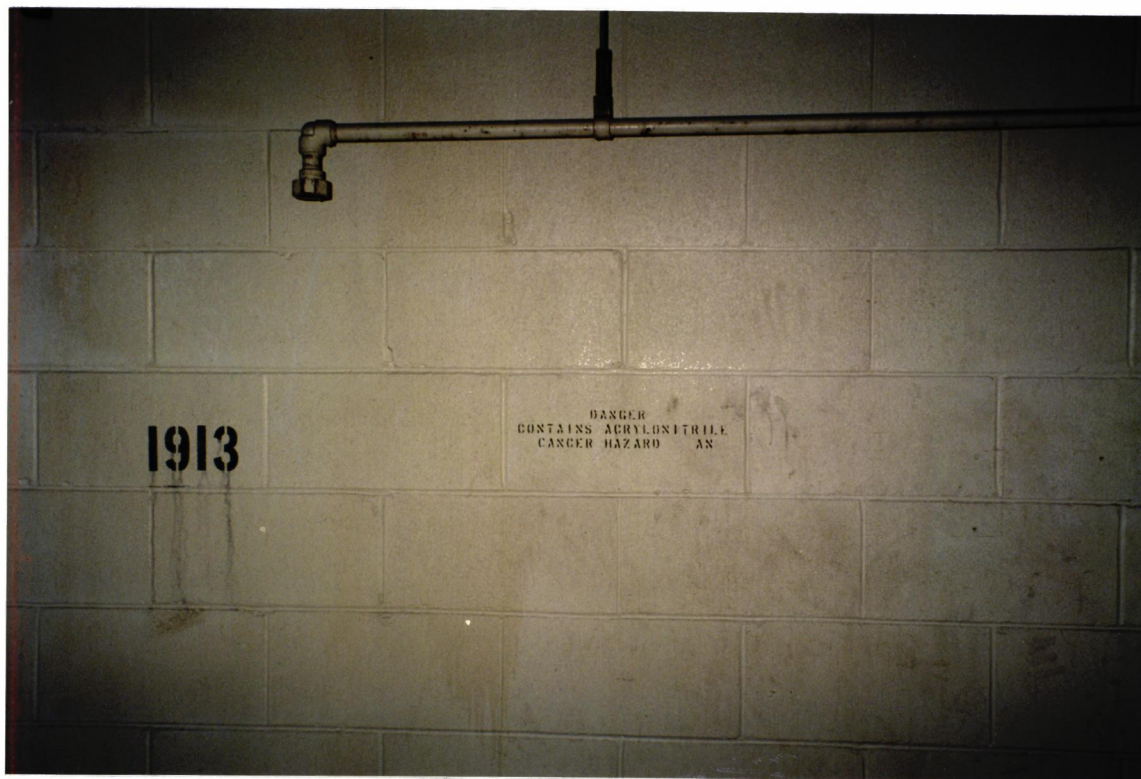
R
O
L
L
2
P
H
O
T
O
12

Facility: Thomas Hayward Agriculture & Nutrition
Location: Kansas City, KS **Photographer:** Jeffery Robichaud **Witness:** James Aycock **Date:** 6/27/95
Direction: East **Camera Type:** Fuji 35mm **Film Type:** 200 ASA **Time:** 1028
Subject: View of writing on wall that identifies that this portion of the building formerly contained a process involving acrylonitrile.

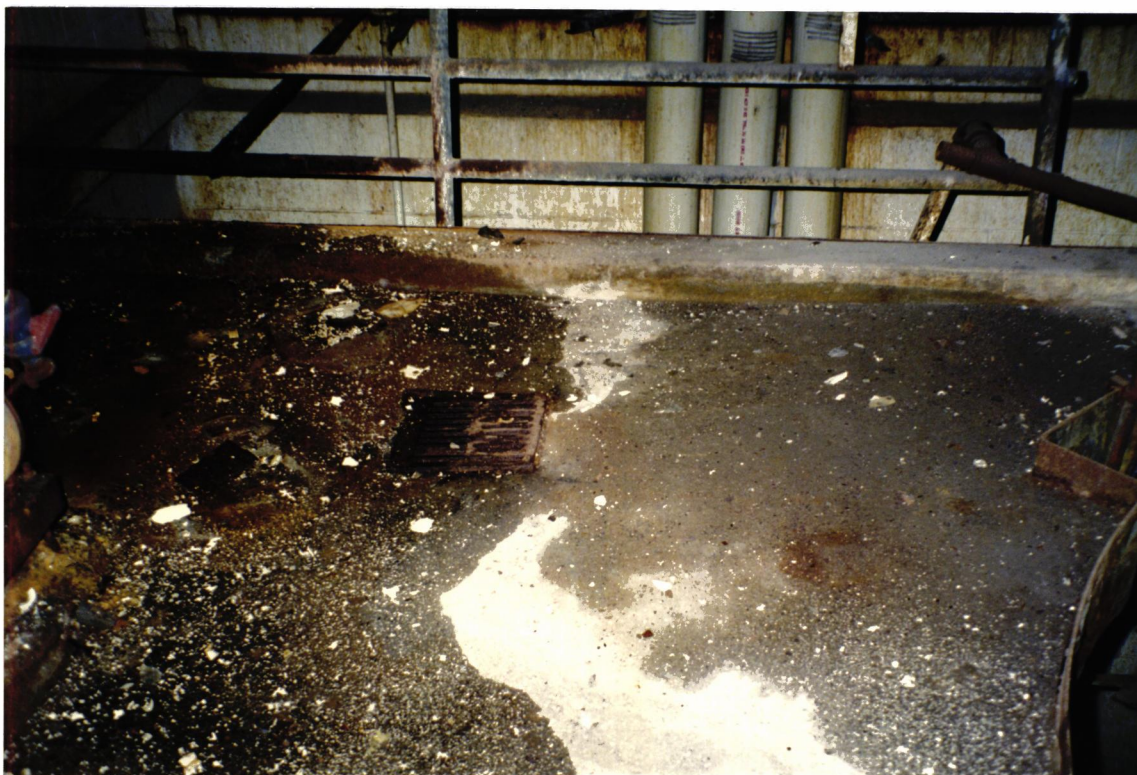
14

Facility: Thomas Hayward Agriculture & Nutrition
Location: Kansas City, KS **Photographer:** Jeffery Robichaud **Witness:** James Aycock **Date:** 6/27/95
Direction: N/A **Camera Type:** Fuji 35mm **Film Type:** 200 ASA **Time:** 1032
Subject: View of the floor drain located in the former reactor room on the second floor.

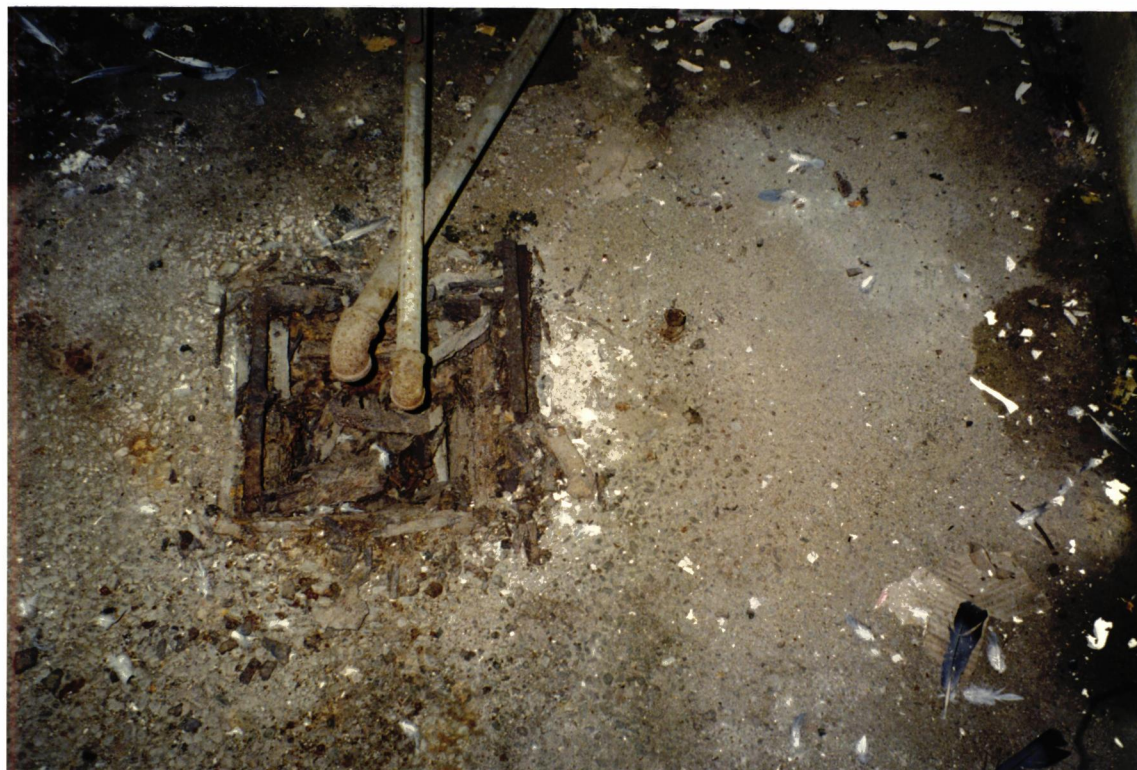
15

Facility: Thomas Hayward Agriculture & Nutrition
Location: Kansas City, KS **Photographer:** Jeffery Robichaud **Witness:** James Aycock **Date:** 6/27/95
Direction: N/A **Camera Type:** Fuji 35mm **Film Type:** 200 ASA **Time:** 1035
Subject: View of the floor drain located in the southeast corner of a room on the west side of the second floor.

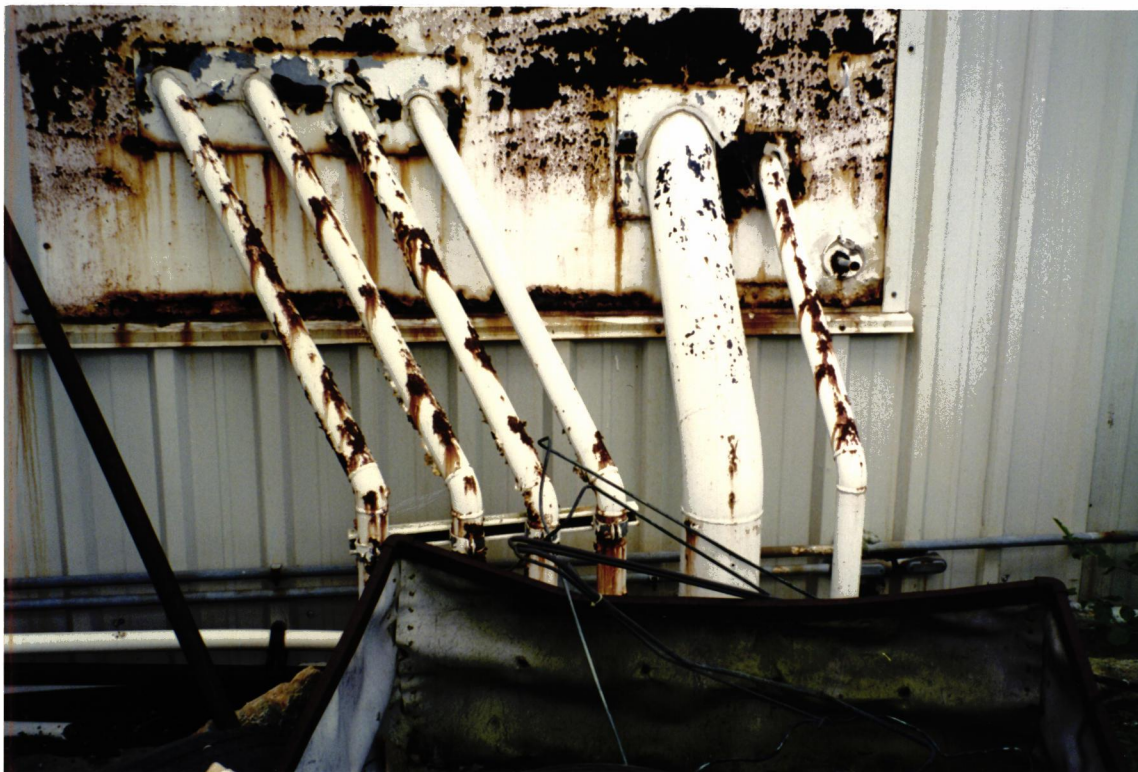
16

Facility: Thomas Hayward Agriculture & Nutrition
Location: Kansas City, KS **Photographer:** Jeffery Robichaud **Witness:** James Aycock **Date:** 6/27/95
Direction: South **Camera Type:** Fuji 35mm **Film Type:** 200 ASA **Time:** 1045
Subject: View of unknown pipes leading into/out of the northwest corner of the former DAITOM plant.

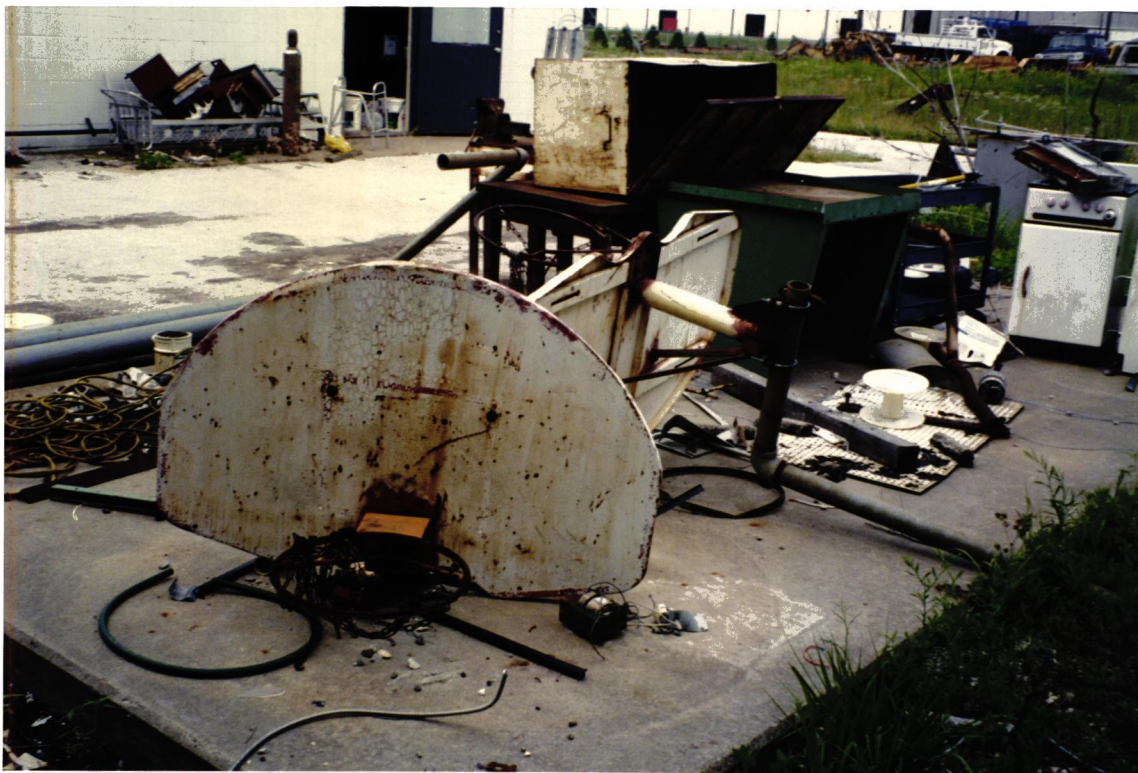
17

Facility: Thomas Hayward Agriculture & Nutrition
Location: Kansas City, KS **Photographer:** Jeffery Robichaud **Witness:** James Aycock **Date:** 6/27/95
Direction: Southwest **Camera Type:** Fuji 35mm **Film Type:** 200 ASA **Time:** 1050
Subject: View of a former tank control pad located to the north of the lab building.

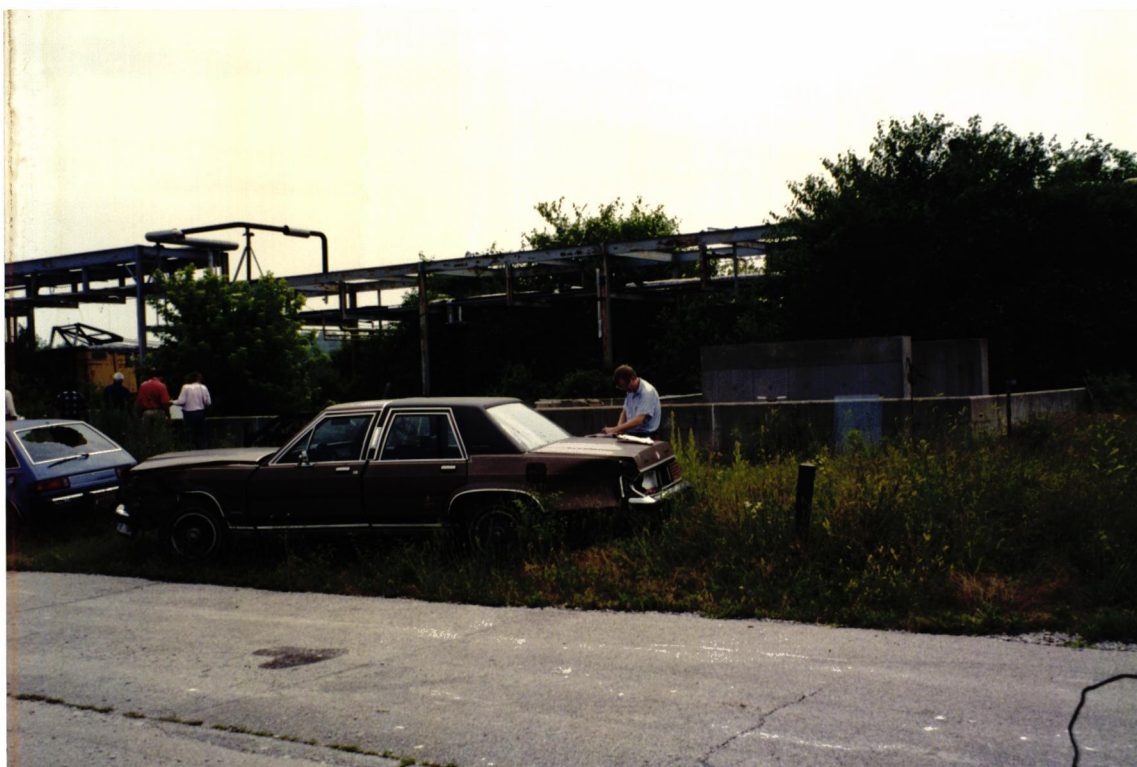
18

Subject: View of the former Brine, Freon, and Mehanol tank location (North of the lab building).

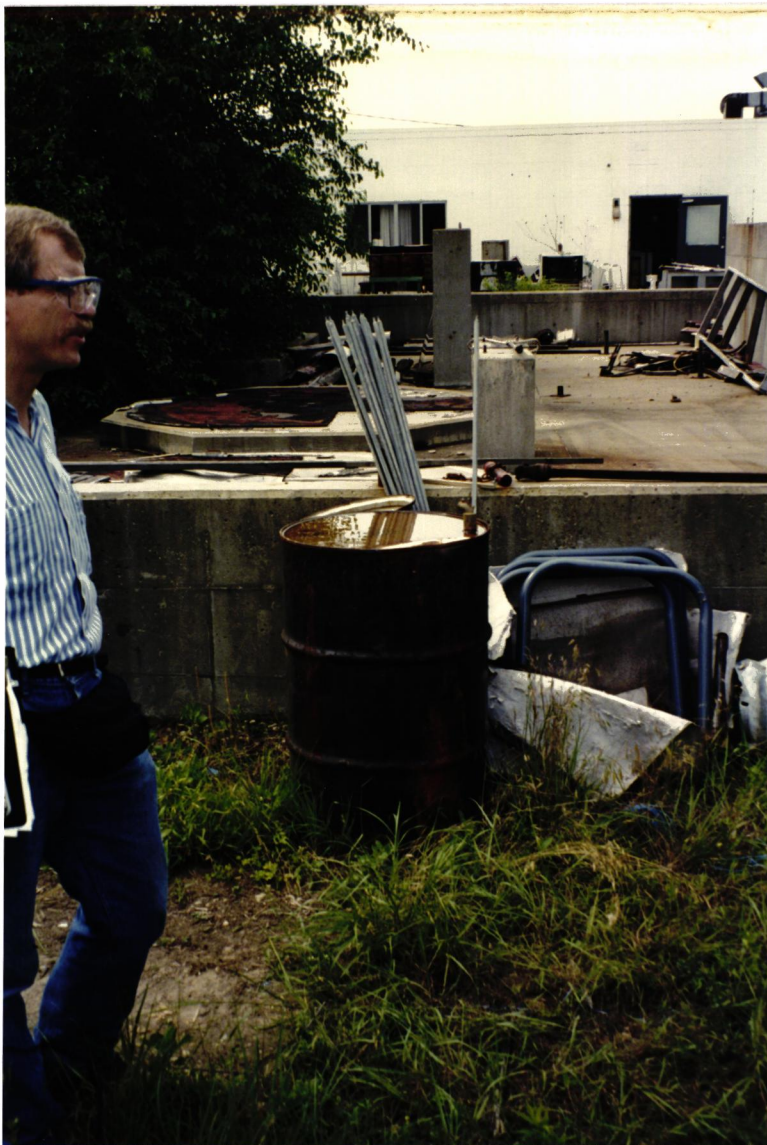
ROLL 2 PHOTO 19

Subject: View of a corroded drum of what appeared to be solid or dried paint to north of the former Brine, Freon, and Methanol pad. Note streaks on the side of the drum and dark spots near the top of drum which are holes. Appears to be stressed vegetation in proximity of drum.

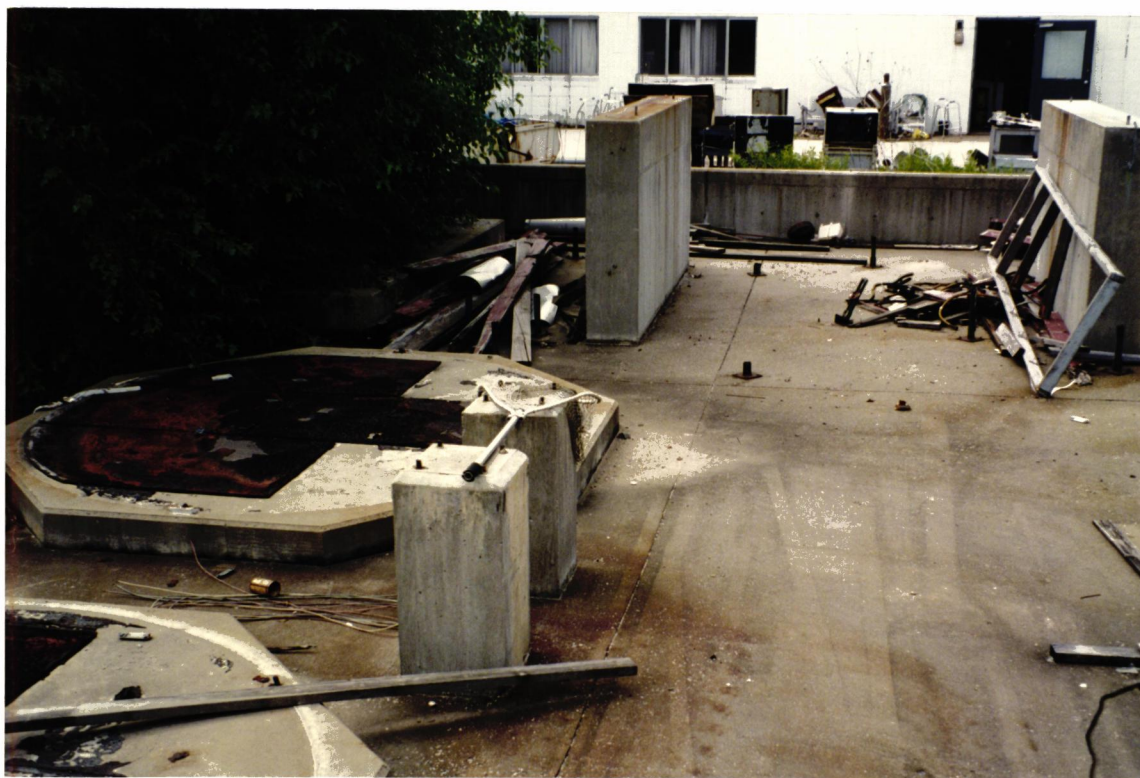
Facility: Thomas Hayward Agriculture & Nutrition
Location: Kansas City, KS **Photographer:** Jeffery Robichaud **Witness:** James Aycock **Date:** 6/27/95
Direction: South **Camera Type:** Fuji 35mm **Film Type:** 200 ASA **Time:** 1055
Subject: View of the former Brine, Freon and Methanol pad taken from top of its containment wall. Note staining on the floor of the pad.

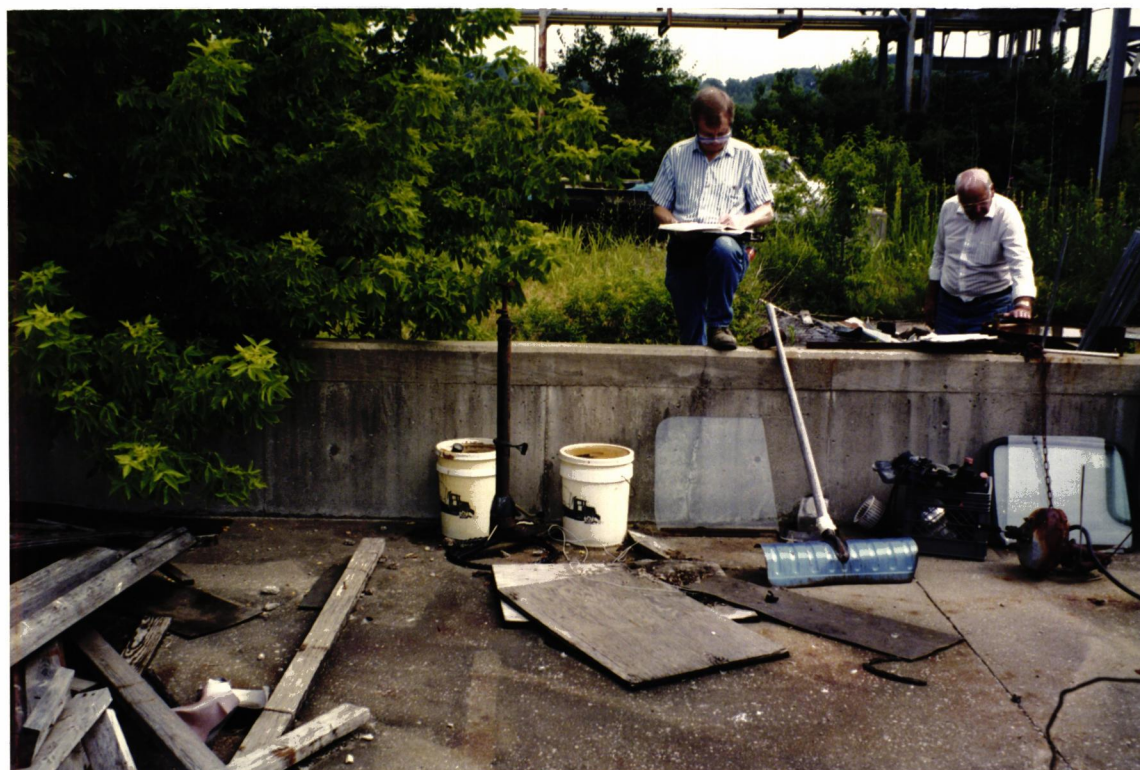
21

Facility: Thomas Hayward Agriculture & Nutrition
Location: Kansas City, KS **Photographer:** Jeffery Robichaud **Witness:** James Aycock **Date:** 6/27/95
Direction: North **Camera Type:** Fuji 35mm **Film Type:** 200 ASA **Time:** 1056
Subject: View of the north side of containment wall for the former Brine, Freon, and Methanol pad. Note the two 5-gallon pails. Unknown contents.
